# espc:home report

15 Birrell Close  
KIRKCALDY  
KY1 2NT

# SINGLE SURVEY

survey report on:

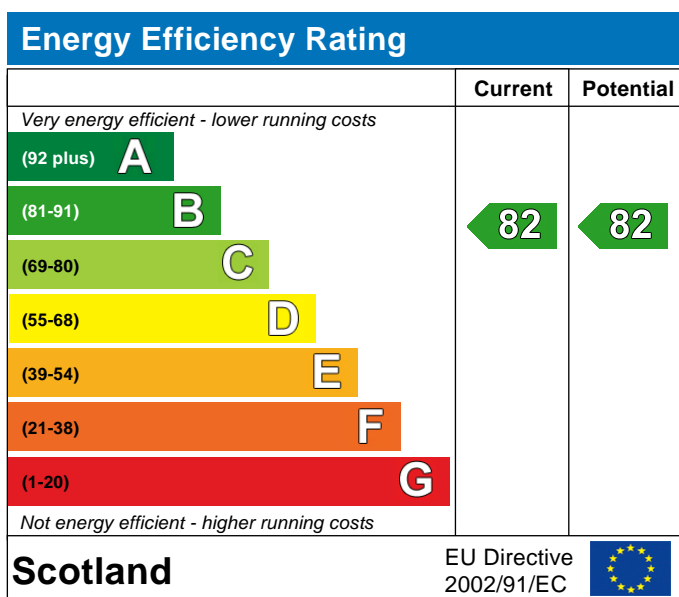
The energy efficiency rating is a measure of the overall efficiency of a home. The higher the rating the more energy efficient the home is and the lower the fuel bills will be.

Approximate current energy use per square metre of floor area: 154 kWh/m<sup>2</sup> per year

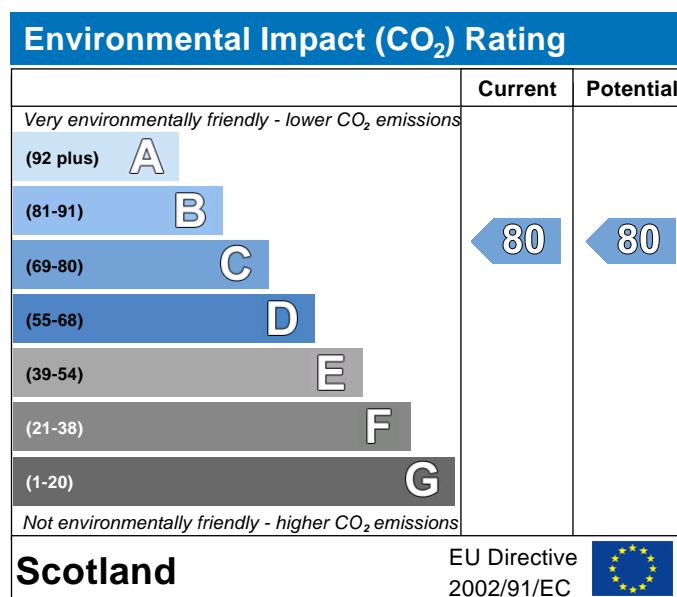
Approximate current CO<sub>2</sub> emissions: 26 kg/m<sup>2</sup> per year

The environmental impact rating is a measure of a home's impact on the environment in terms of carbon dioxide (CO<sub>2</sub>) emissions. The higher the rating the less impact it has on the environment.
