espc:home report

110 Greenbank Crescent
EDINBURGH
EH10 5SX

SINGLE SURVEY

Prepared by	Nick Bonnar, MRICS
--------------------	--------------------

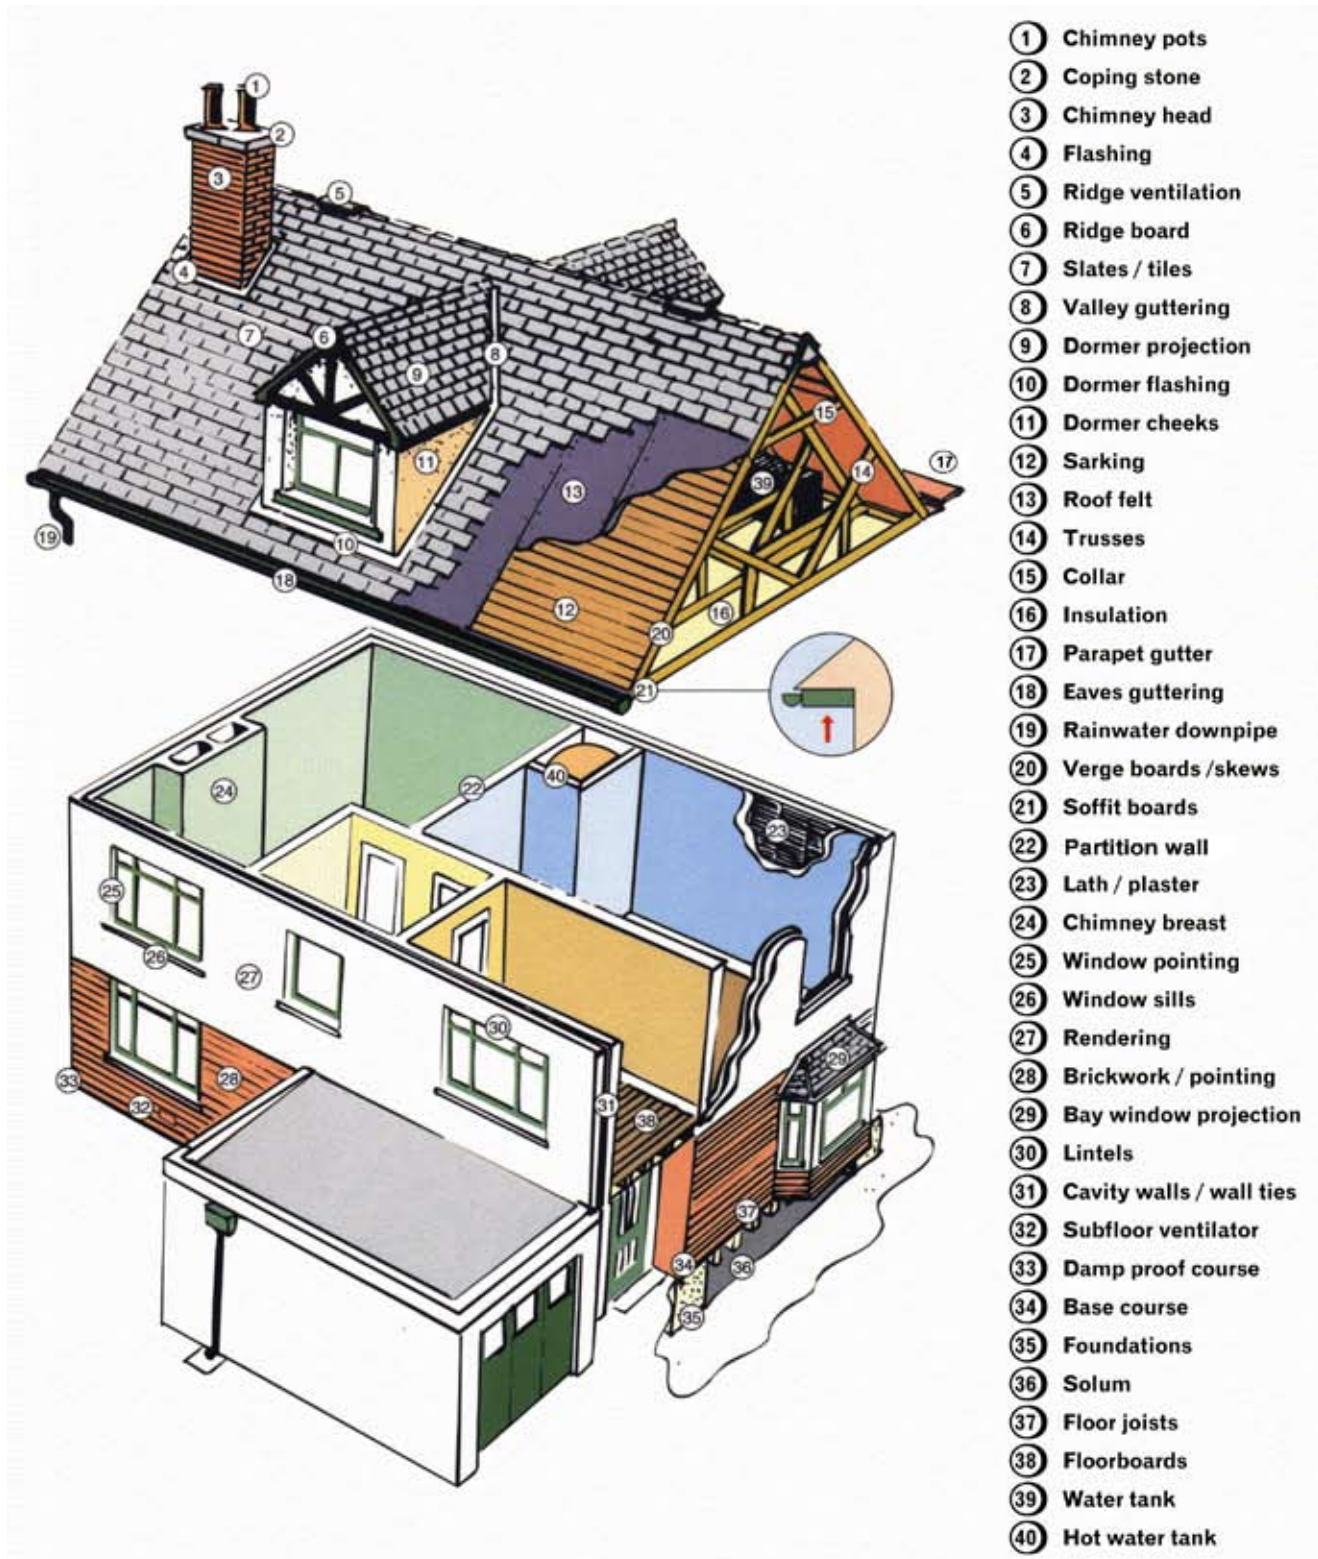
Sectional Diagram showing elements of a typical house

Reference may be made in this report to some or all of the above component parts of the property. This diagram may assist you in locating and understanding these items.
